Lightning Strikes and Stainless Steel Rigging: The Case for Replacement

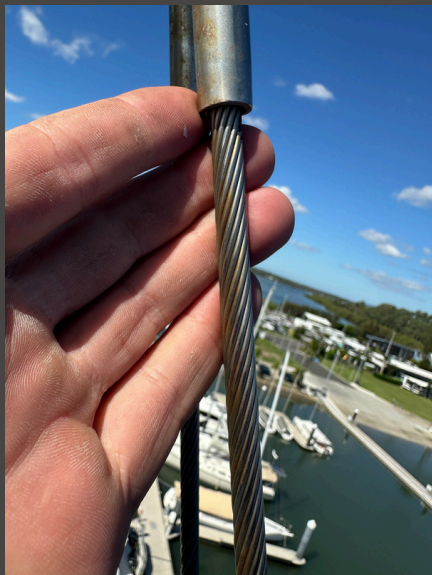
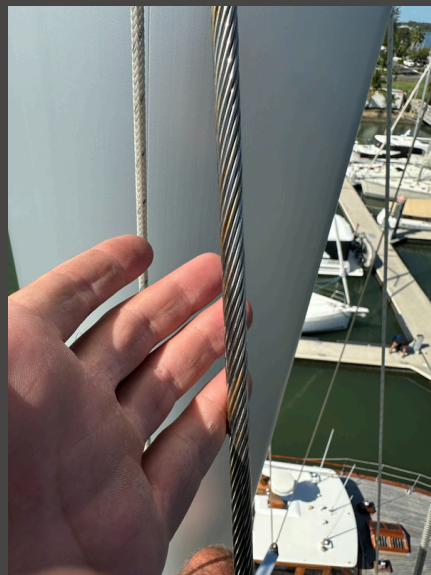
- Barber Pole Staining: Whilst common in marine environments, when combined with other indicators such as burn marks or powder residue, it can be evidence of electrical damage.

- White Powder Residue: This is typically a sign of surface breakdown, where heat and electrical energy have corroded the steel's surface layer.
- Burn Marks or Melting: Visible scorching or melted fittings are clear indicators of excessive heat and potential molecular damage.

- Heat Tinting (Blue Discolouration): This indicates exposure to extreme temperatures and should be considered a sign of compromised integrity.
- Electrical Component Damage: If electrical systems on the yacht are found to be fried or malfunctioning post-strike, this is strong evidence that current travelled through the carbon or aluminium mast and stainless rigging to reach the vessel's electrical components. This path of travel is indicative of the rigging carrying high voltage during the event, further supporting the need for replacement.

As the manufacturer of hamma® stainless steel products, we stand firmly behind our commitment to safety and quality. Our recommendation is clear: if rigging has been exposed to a lightning strike, it should be replaced. The risk of latent structural damage that could lead to failure under load is too high to ignore. This is not about insurance disputes - it's about safety and best practice within the marine industry.

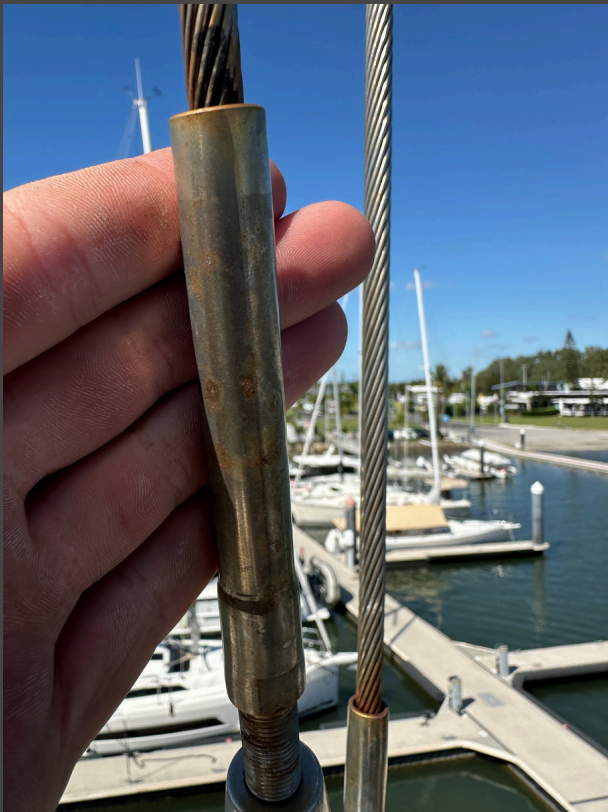
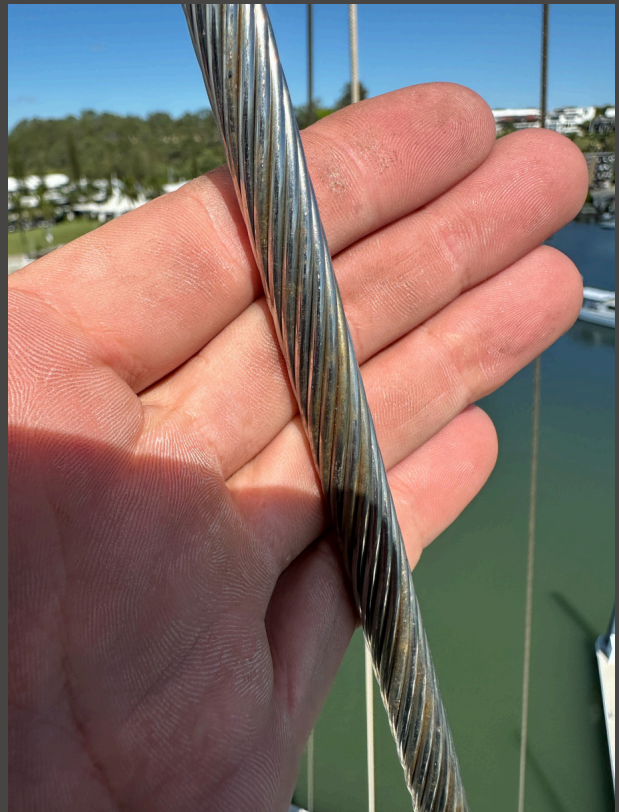
The rigging shown in these images is slightly over 12 months old and is European-made, not branded as hamma®. These photos are provided purely as evidence to support the technical information presented in this article and are not indicative of hamma® product performance.
